# - Service Campaign

# 6382

## TBM - NO GEOLOCATION FUNCTION

On a batch of Alfa Romeo Giulia and Stelvio vehicles, the 3D geolocation function on the RadioNav may not be detected correctly. For this reason, it is necessary to install some software updates on the RadioNav to restore the correct operation of the geolocation function.

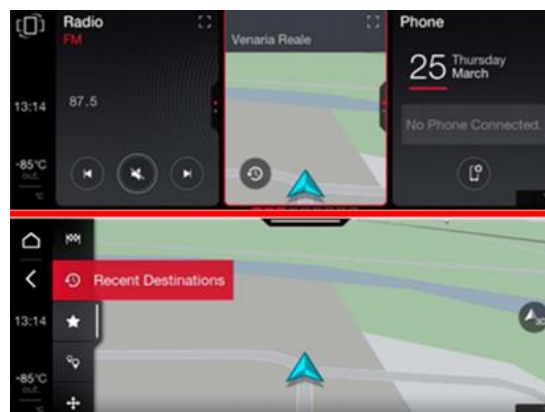
- Switch on the system and on the press the "Navigation" widget Home screen.
- Press the "Recent Destinations" icon.

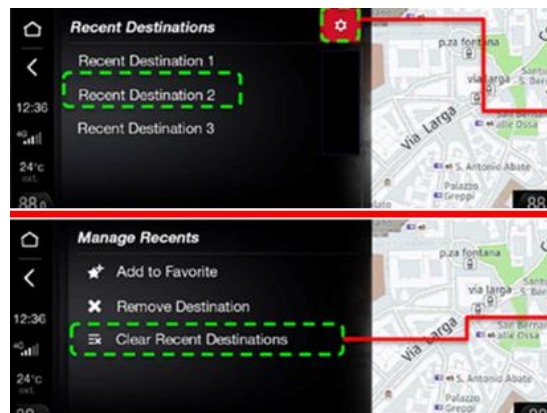
- Press the "Settings".
- Press the "Delete recent destinations" command.

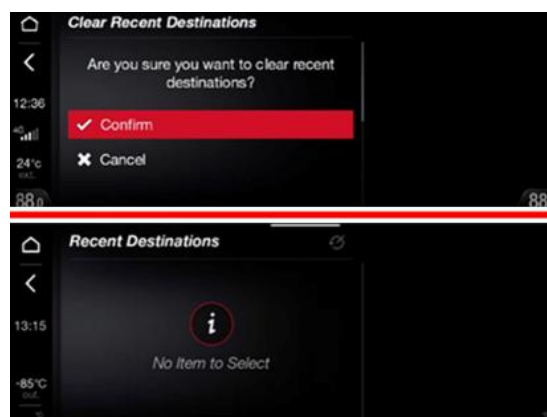
- Confirm the deletion.
- After deletion, the list will appear empty.

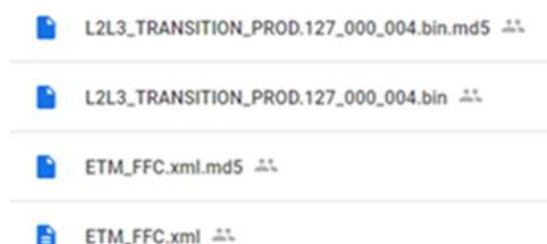
- Copy the transition software to the root of a USB pendrive1.

**⚠ The USB pendrive must be empty, No other files must be present on the device and there must be no nested folders.**

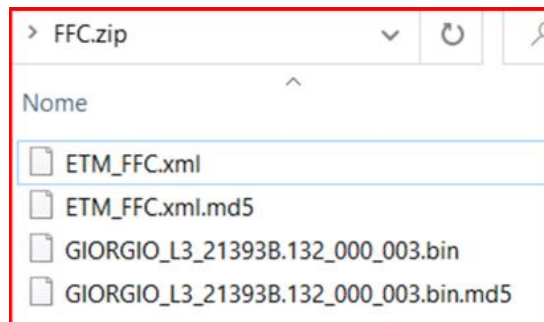
- Copy the target software to the root of a USB pendrive2.

**⚠** *The USB pendrive must be empty, No other files must be present on the device and there must be no nested folders.*

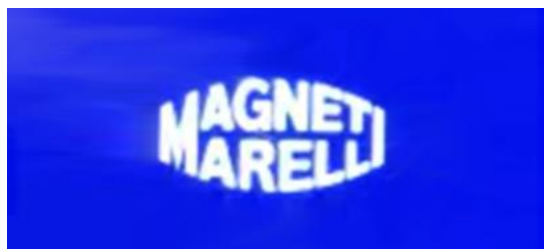
- Remove any media connected to the USB port.
- Connect the USB pendrive1 containing the transition software to the USB port of the system.
- After a few seconds, the following message will be displayed on the screen: "To stop flashing, remove the USB device. To start it, confirm with OK".
- Press OK to start the installation of the transition software:

- A blue screen with Marelli logo will appear.

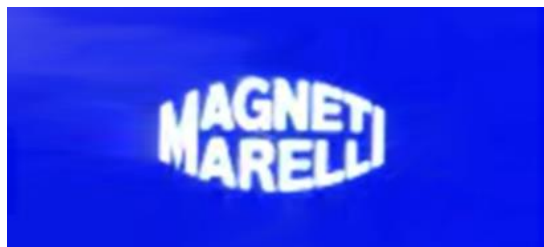
- The counter for the integrity check is displayed on the same screen.
- The radio is rebooted.
- After rebooting, the message "Transition successful" and a green bar will appear.
- The radio will reboot in "Maintenance mode" (blue screen with "Marelli" logo).

- The radio will reboot in "Maintenance mode" (blue screen with "Marelli" logo).

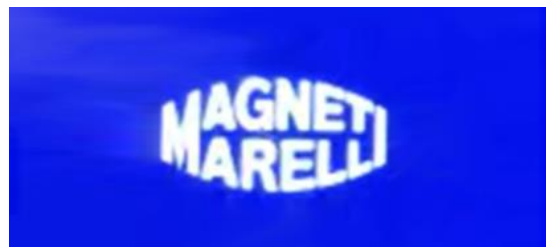
- Switch on the system if it has not been switched on before.
- Remove any media connected to the USB port.
- Connect the USB pendrive2 containing the target software to the USB port of the system.
- Installation of the target software will start after a few seconds.

- A blue screen with Marelli logo will appear.

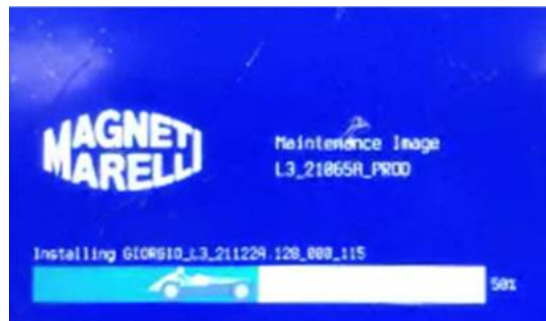
- After rebooting, the BLUE screen with the "Marelli" logo will appear again also contains a bar indicating the progress of the installation in progress.

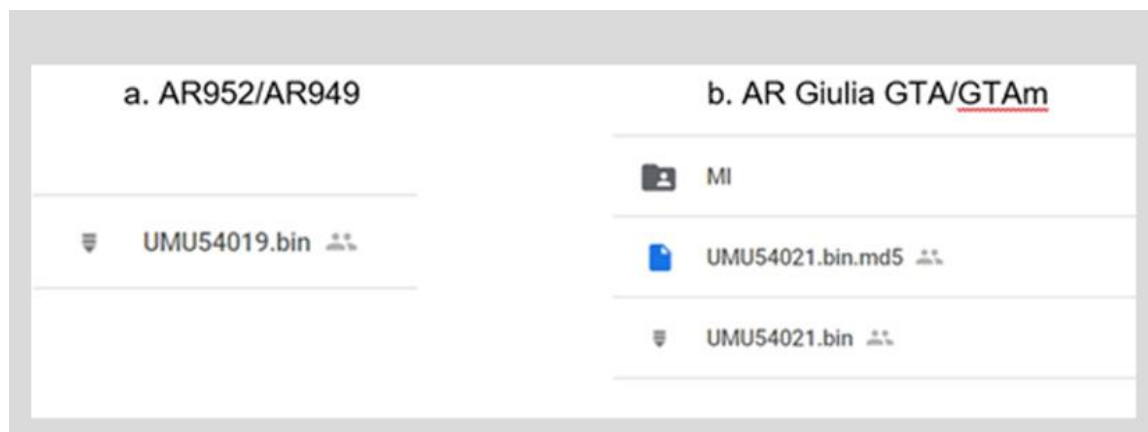
- Copy the electronic Owner Handbook software to the root of a USB pendrive according to the following images:

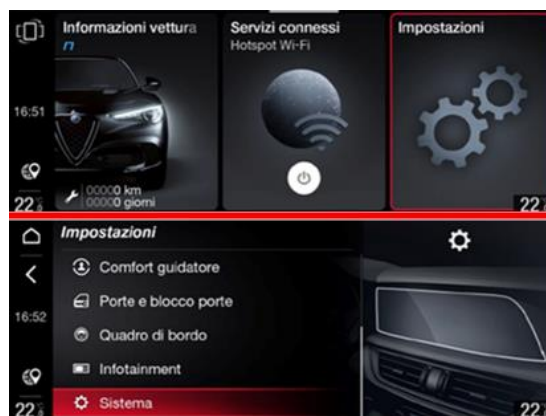
- Select the "Settings" menu from the main menu.
- Select "System" in the "Settings" menu.

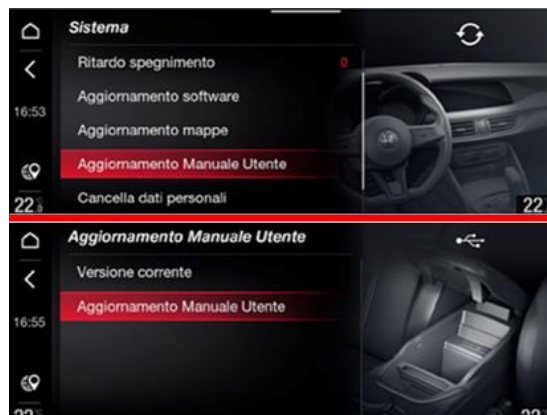
- Select "Owner Handbook update".
- Then select "Owner Handbook Update" again.

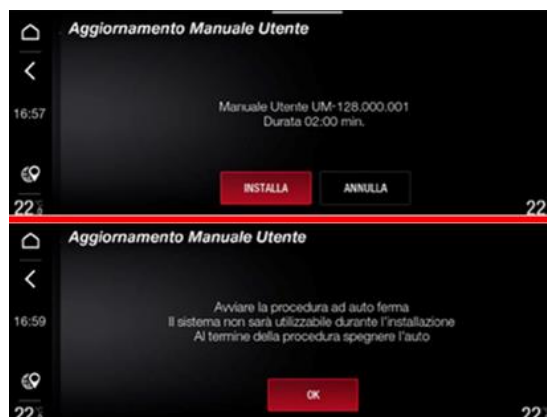
- Insert the pendrive into the USB port indicated on the HMI.
- Click on "Owner Handbook update". The following screen will appear.
- Select "INSTALL" to start installing the Owner Handbook.
- Press OK on the following screen.

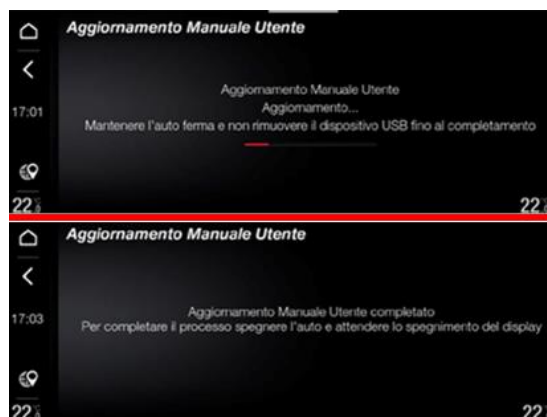
**Keep the car stationary and do not remove the USB pendrive until completion.**
- When the update is complete, the screen appears with the warning that the Owner Handbook update is complete.

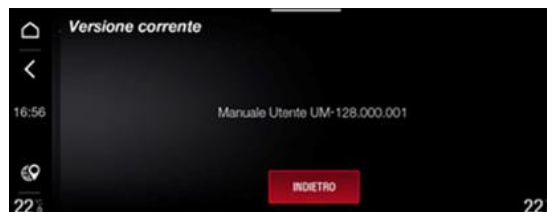
- To check the version of the installed update: in "Home" > "Settings" > "System" > "Owner Handbook update" > "Current version".

- The installed version will be displayed:
  - for AR952/AR949: **UM-128\_000\_002**
  - for AR Giulia GTA/GTAm: **UM-128\_000\_013**

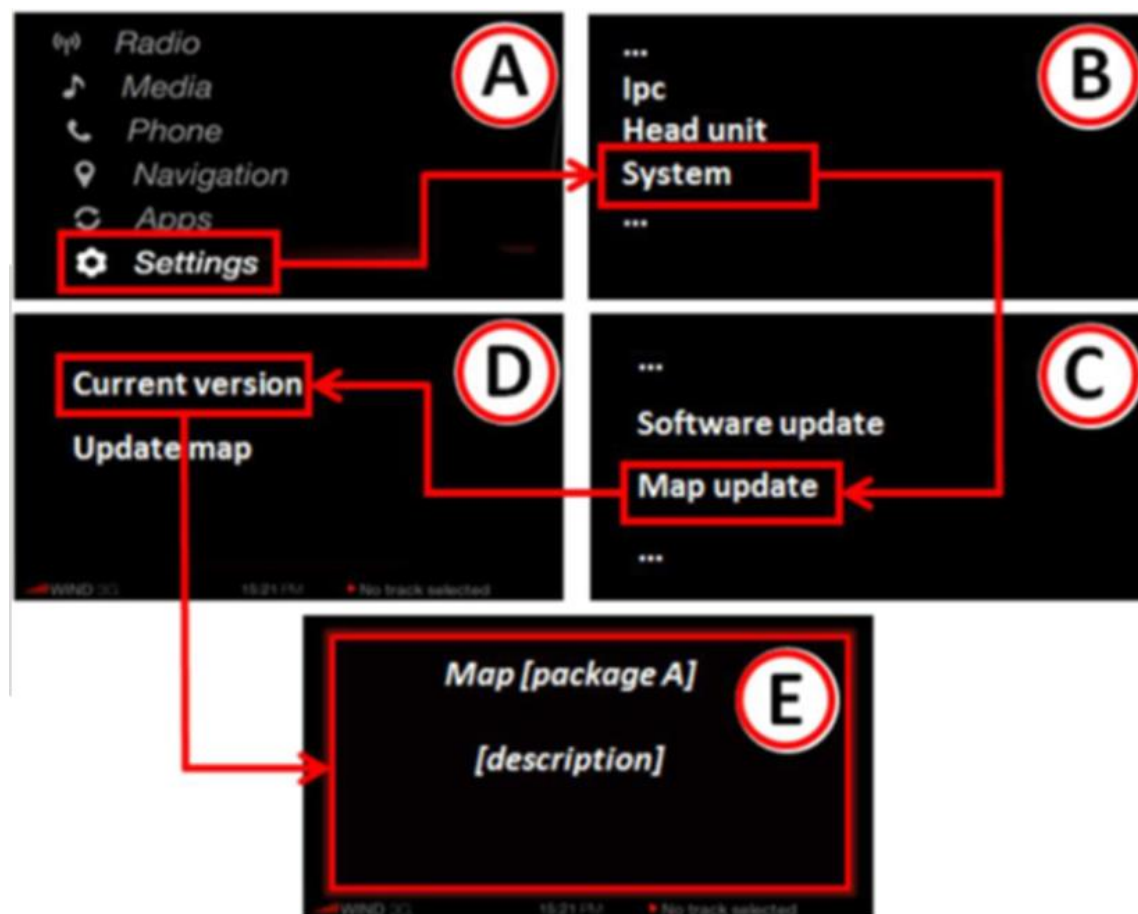
- Select Setting from the main menu (A).
- Select System, Map update and Current version in that order (B, C and D).

- If the map version installed on the navigator (E) is older than "11.0.2021.06" proceed by downloading and installing the updated maps as described in **Step 2**.
- If the map version installed on the navigator (E) is "11.0.2021.06" no update is necessary.
- Hand the vehicle back to the customer.

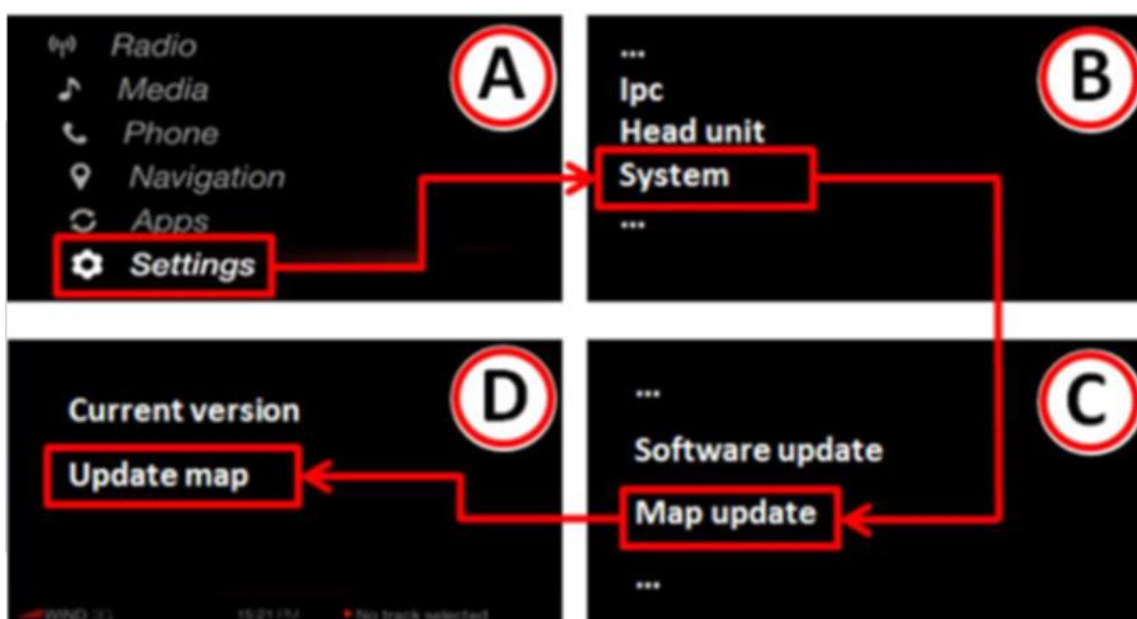
- Select Settings (A) from the main menu, then select System (B), Map update (C) and Map update (D) in sequence.

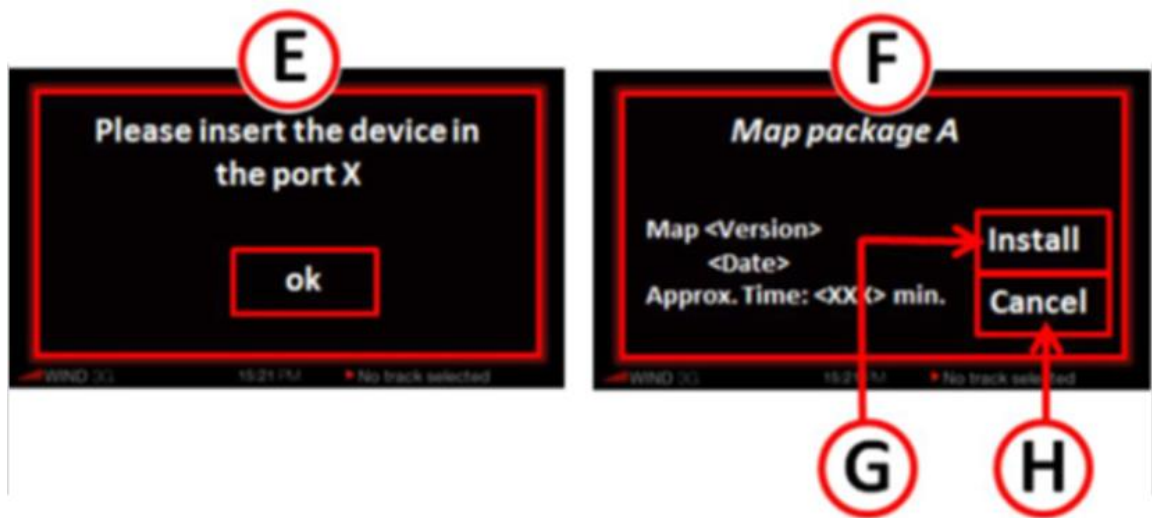
- If the USB flash drive is not connected or is inserted into the wrong port, screen (E) will be displayed.
- If the USB flash drive is inserted correctly, screen (F) will appear.
- Select Install (G) to start map installation. The screen (I) will be displayed.
- Selecting Cancel (H) will return and display the screen (C).

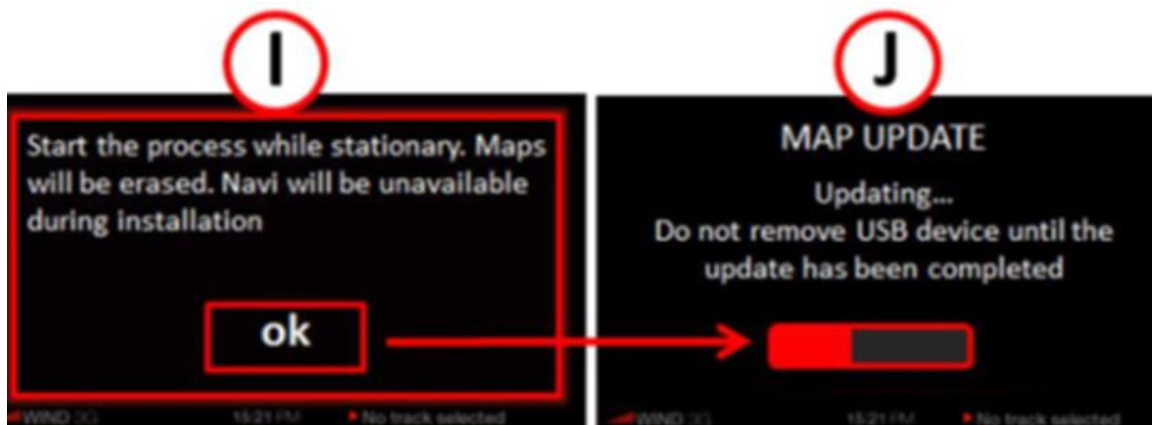
- On screen (I), a message will prompt to start the procedure with the vehicle stationary. The existent maps will be deleted and the navigator will not be available during the new map installation procedure.
- Select OK to start map installation. Screen (J) will be displayed.
- A message will appear on the screen (J) reminding you that while installing the map, the USB flash drive must remain inserted until the procedure has finished.
- During installation, a bar is displayed that will be progressively filled in, showing progress. Once the process has been started, it will be impossible to interrupt it.

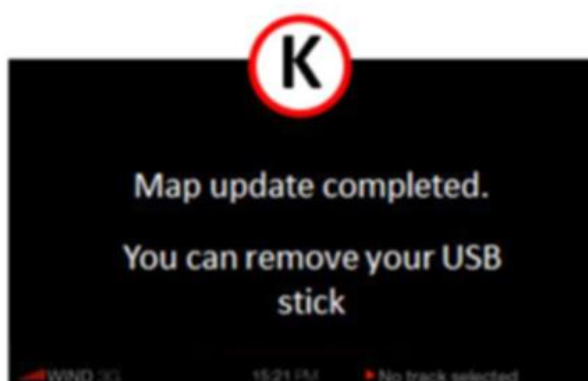
- Wait for the procedure to complete, when an indication that the update was finished successfully will appear on the screen (K).
- At this point, only after the screen (K) has been displayed, you can remove the USB flash drive.

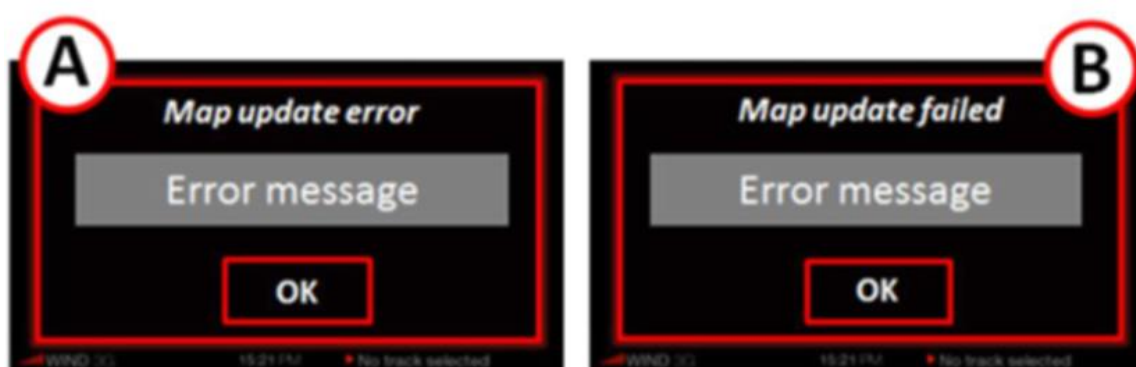
- Errors displayed before the installation process (A).
- Errors displayed during the installation process (B).
